# **Navajo Abandoned Uranium Mine**

## **Site Screen Report**

### **Billy Topaha Mine AUM Site**

**March 2010**

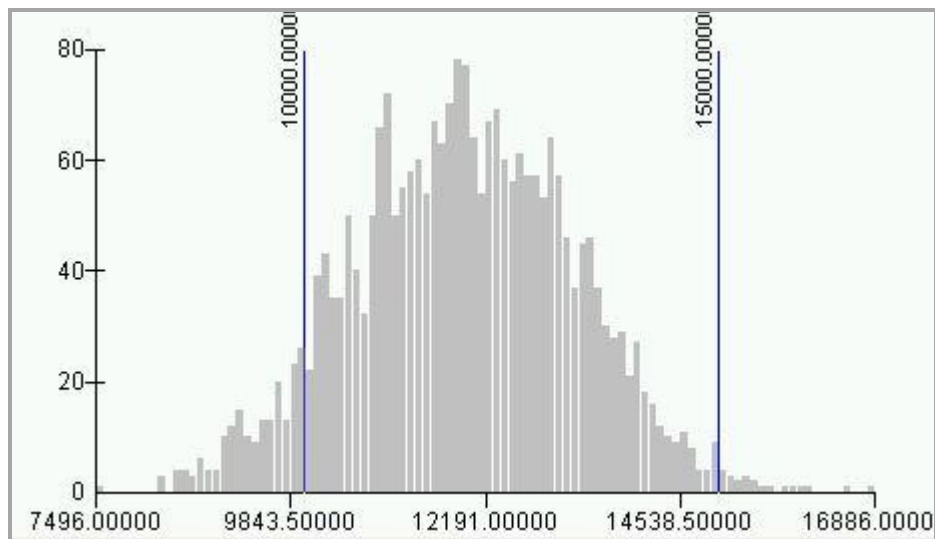
The following chart and statistics were generated by ESRI ArcGIS 9.3.1, and show the general distribution of the site gamma radiation measurements. The horizontal X axis represents the gamma radiation reading levels in cpm (lowest levels to the left). The vertical Y axis represents the frequency of each gamma radiation level.

Count:	2497
Minimum:	7496.00000
Maximum:	16886.00000
Sum:	29792778.00000
Mean:	11931.42891
Median:	11933.00000
Standard Deviation:	1332.35856

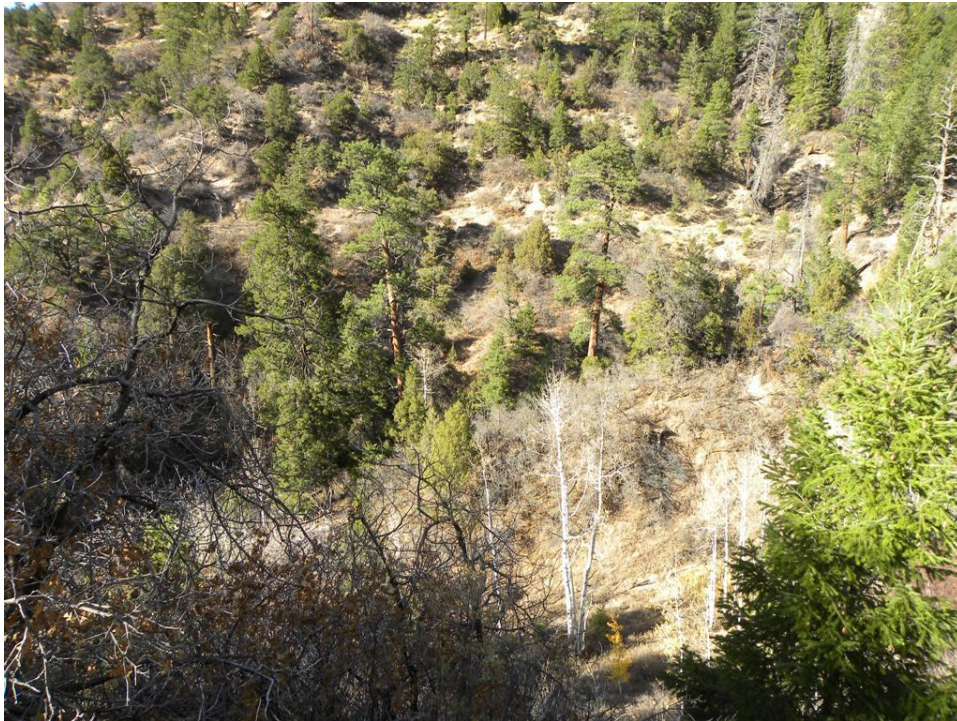
Photo 2. Inaccessible steep grades towards site

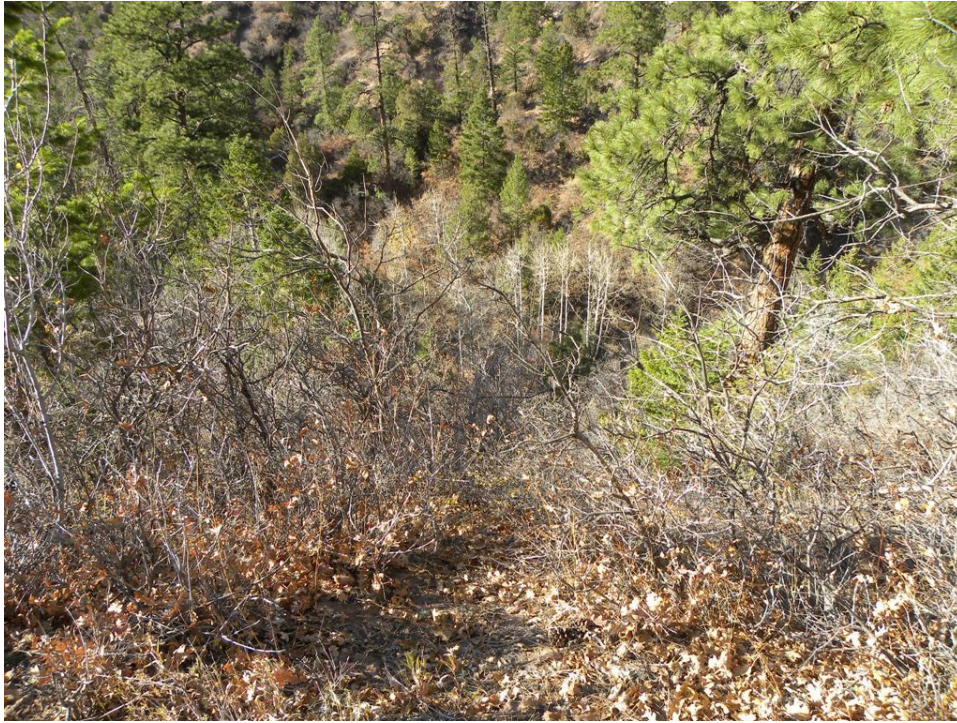
Photo 3. Impassible heavy vegetation towards site

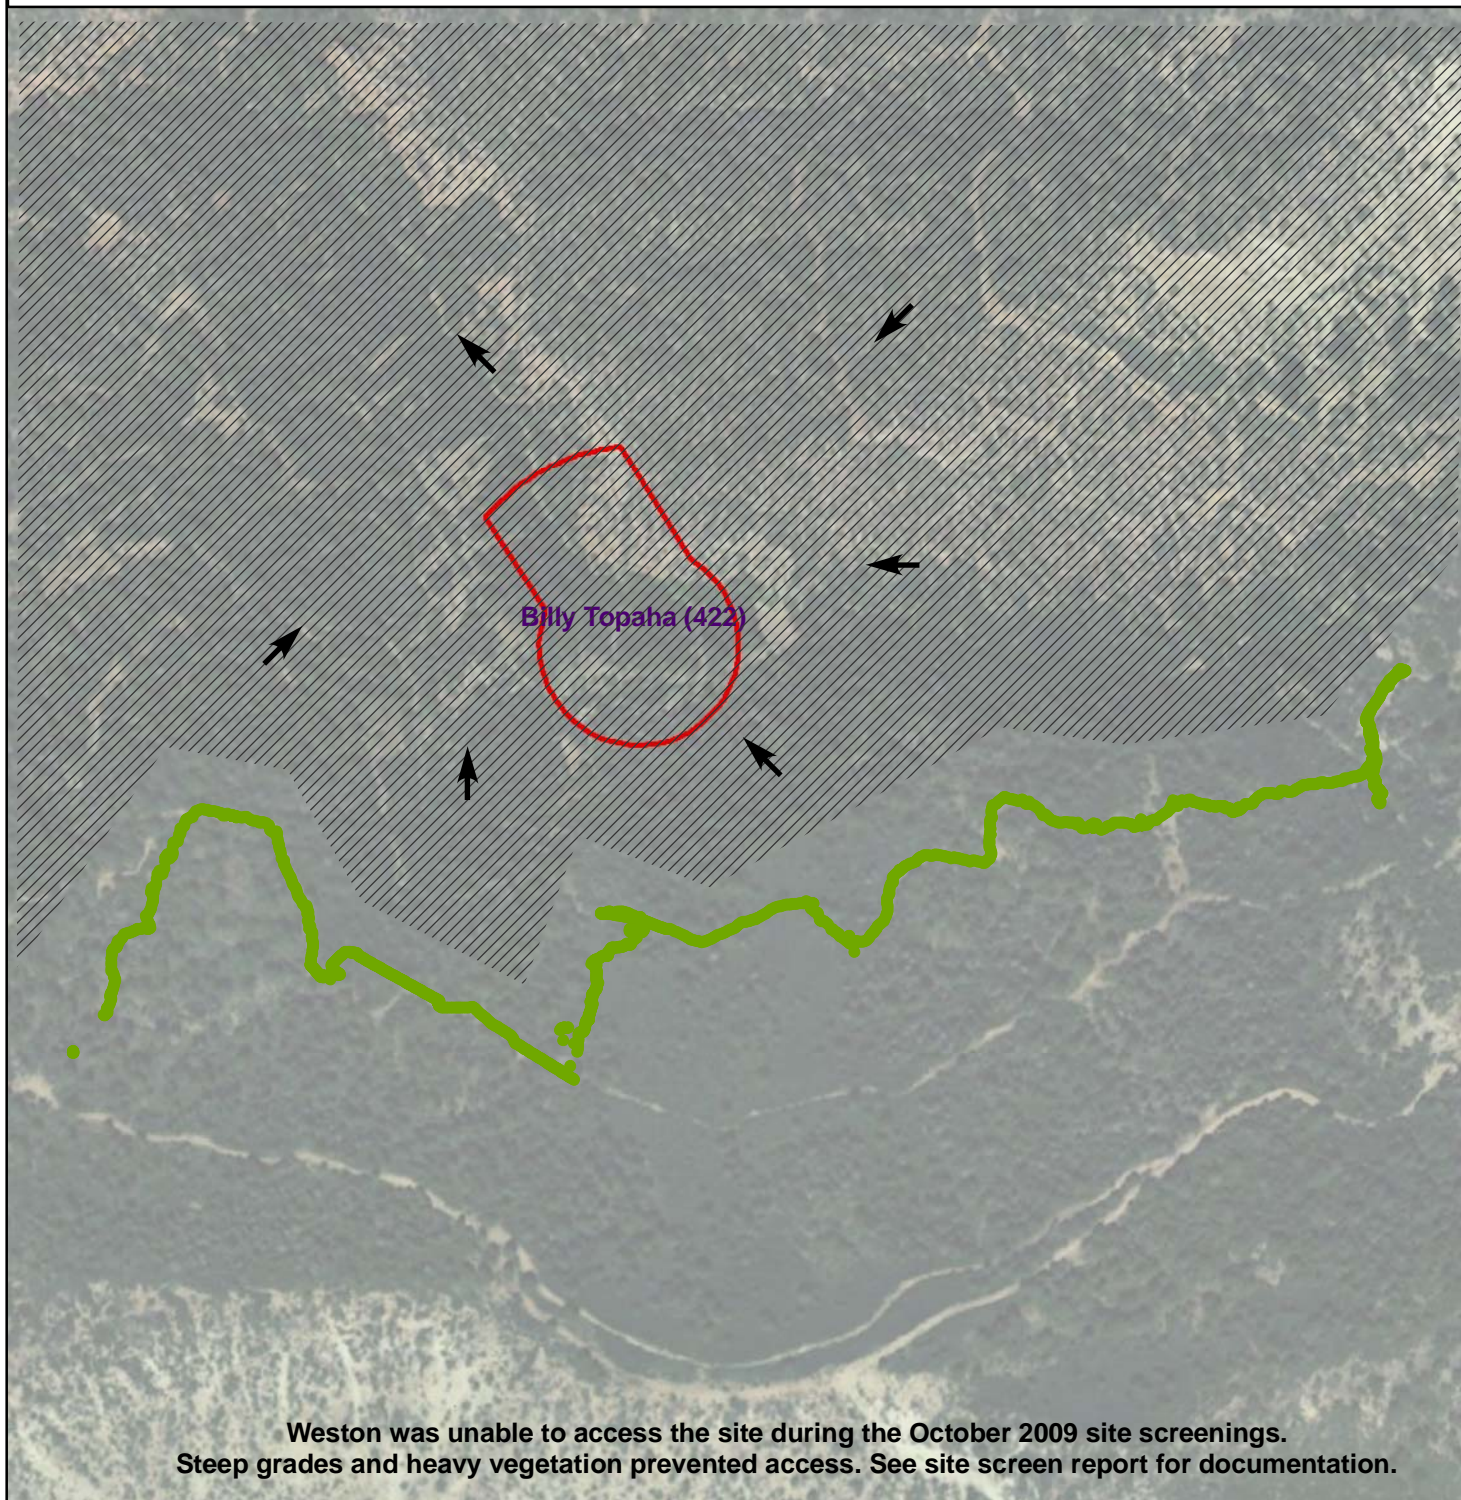
**Figure 1 - Gamma Radiation Measurements, Above Two Times Background  
Billy Topaha (422)  
Cove Chapter, Navajo Nation, Arizona**

Gamma survey conducted 10/2009  
Measured as counts per minute (cpm)

Average background = 10,624 cpm

Inaccessible due to steep grades

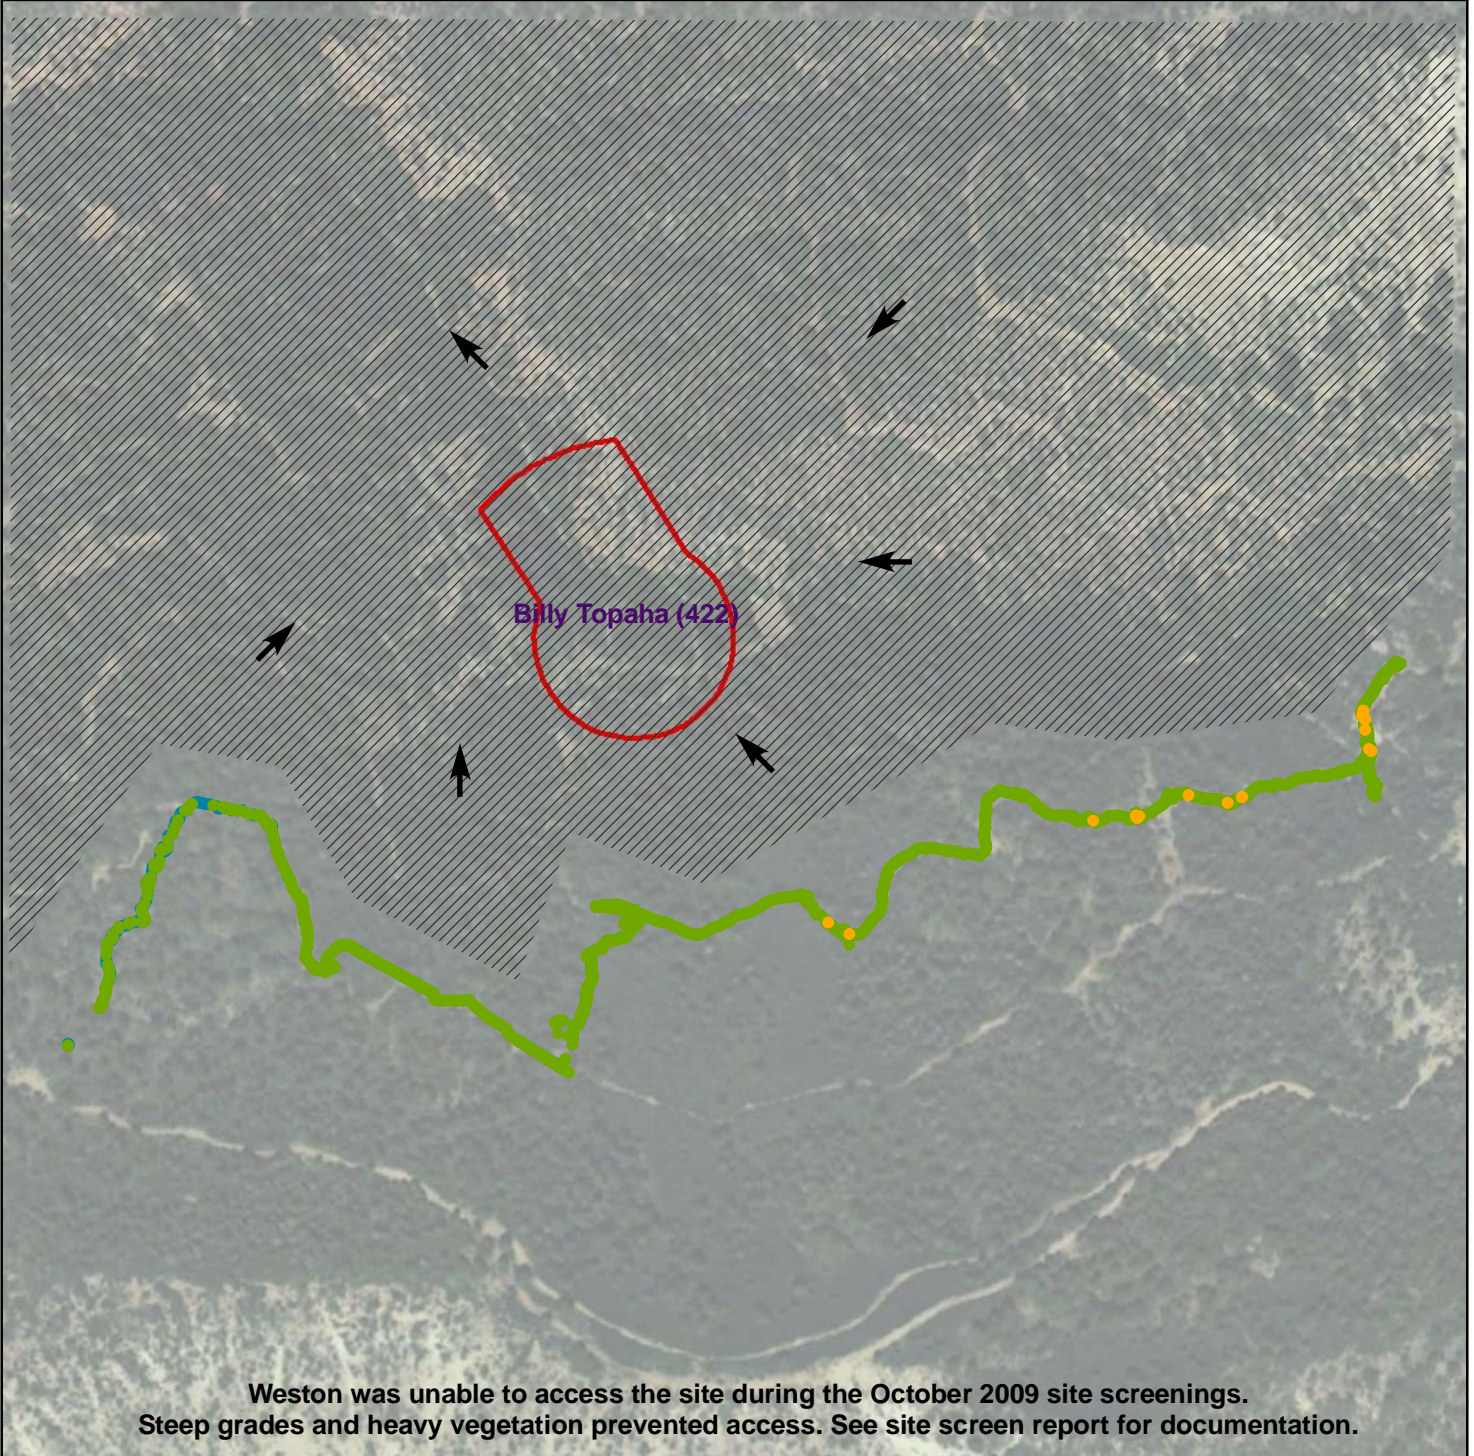
**Figure 2 - Gamma Radiation Measurements**  
**Billy Topaha (422)**  
**Cove Chapter, Navajo Nation, Arizona**

Inaccessible due to steep grades

Gamma survey conducted 10/2009  
 Measured as counts per minute (cpm)
